VOLUME 84 NO. PO4

# **JOURNAL of the**

**AMERICAN SOCIETY  
OF CIVIL ENGINEERS**

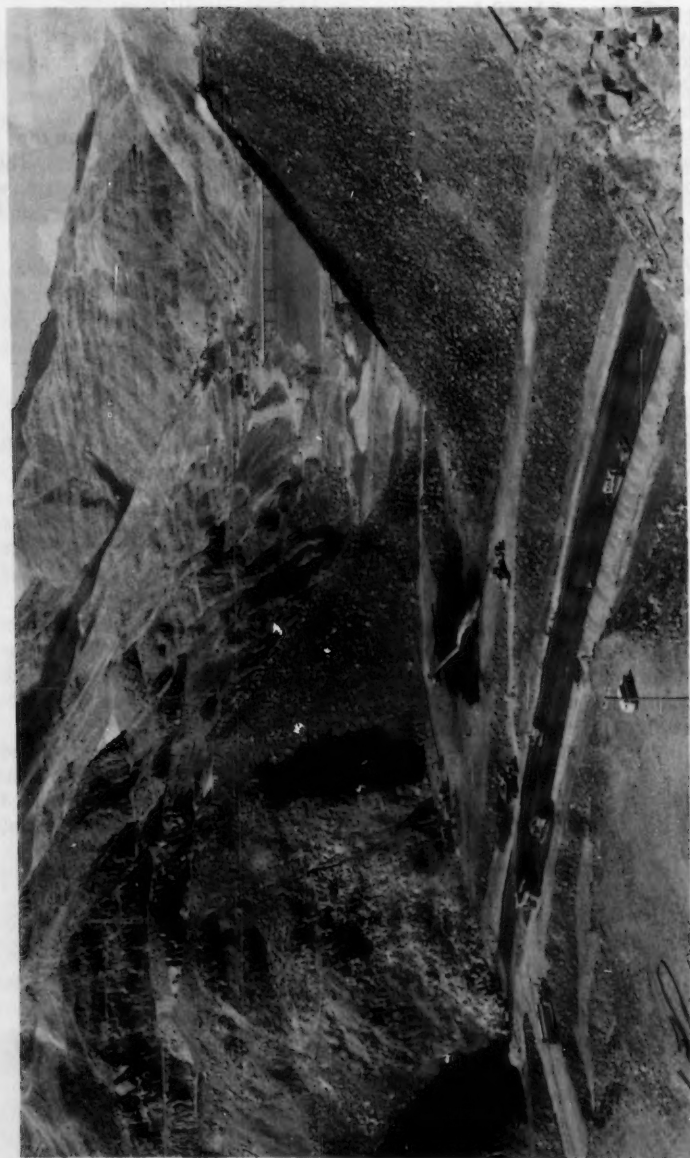
PHOTOGRAPH 1: BROWNLEE DAM DURING CONSTRUCTION  
View looking downstream showing impervious core and  
filter zones and rockfill.

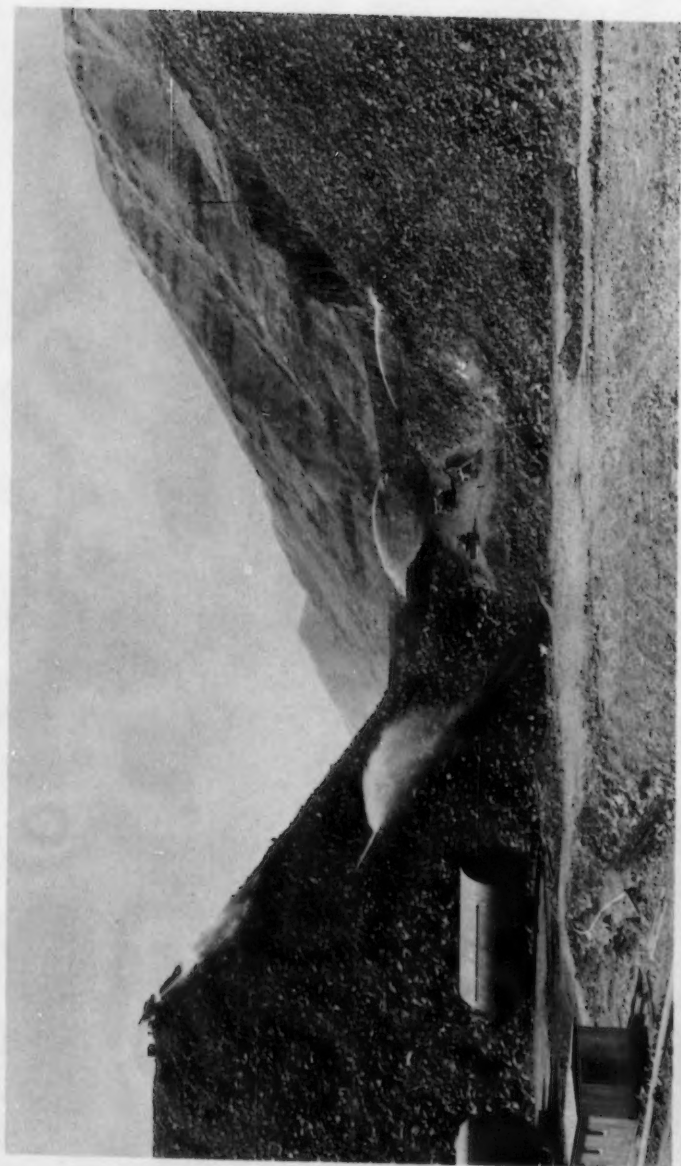
PHOTOGRAPH 2: ROCKFILL CONSTRUCTION

View looking upstream showing dumped  
rockfill being placed and sluiced.

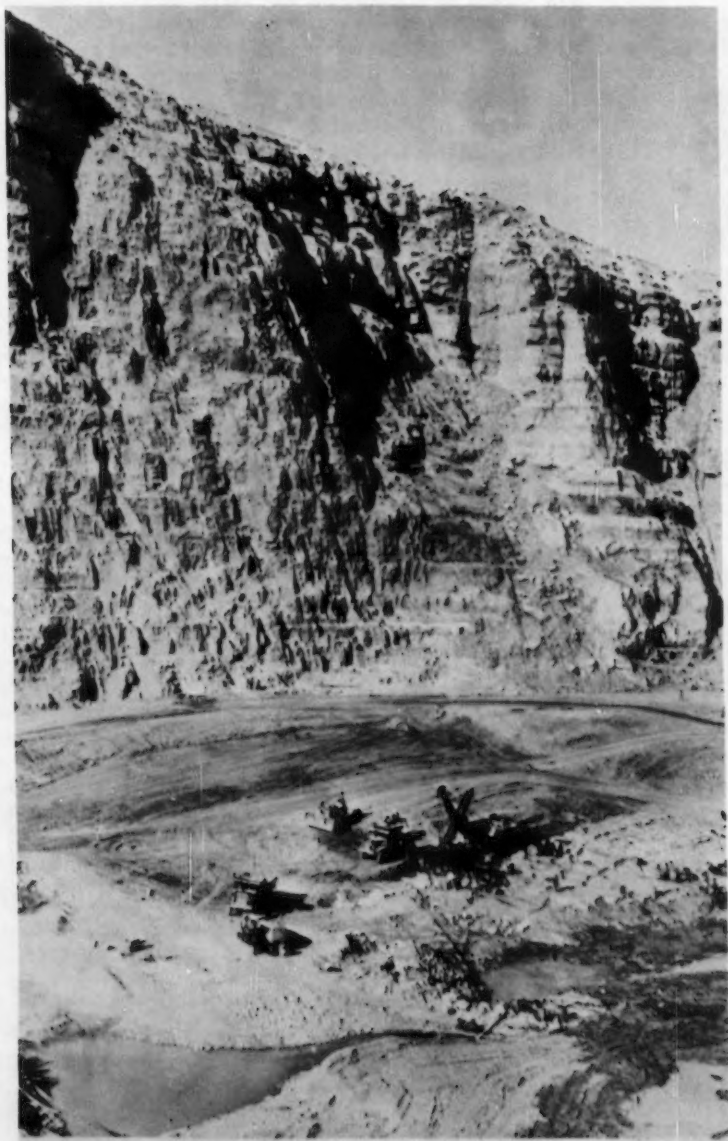
**PHOTOGRAPH NO. 4 KAJAKAI DAM**      **EXCAVATION OF CORE  
TRENCH, START OF IMPERVIOUS CORE FILL, AND STRIPPED  
LEFT ABUTMENT**

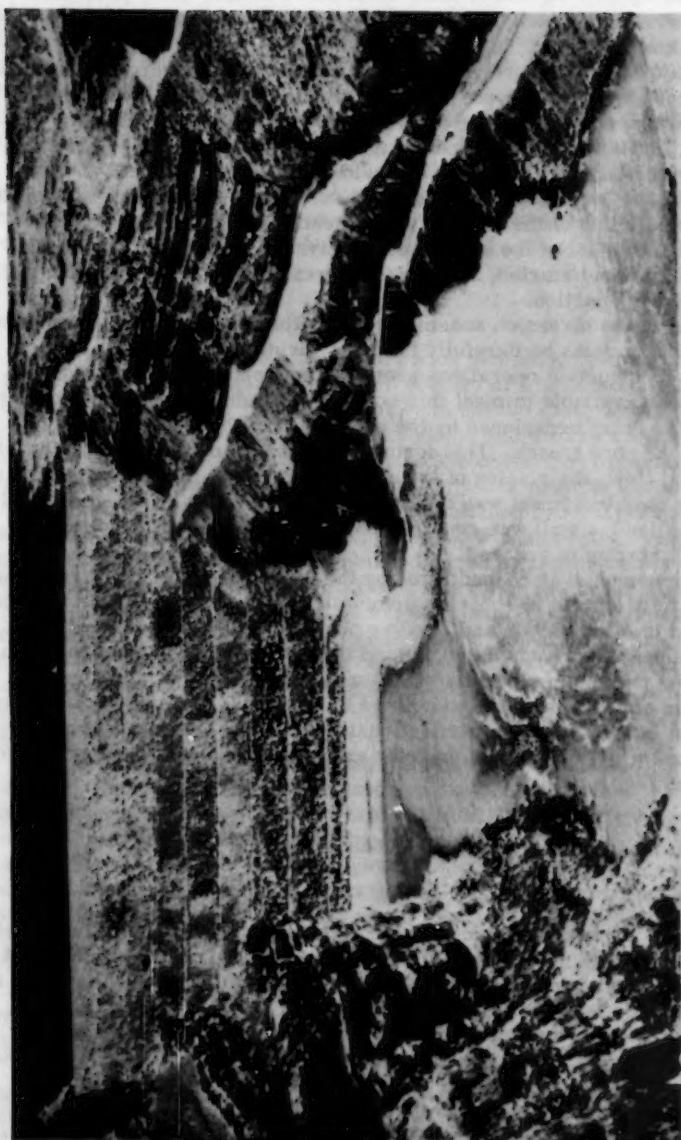
PHOTOGRAPH NO. 1 KAJAKAI DAM

MAIN DAM EMBANKMENT AND OUTLET WORKS  
LOOKING UPSTREAM

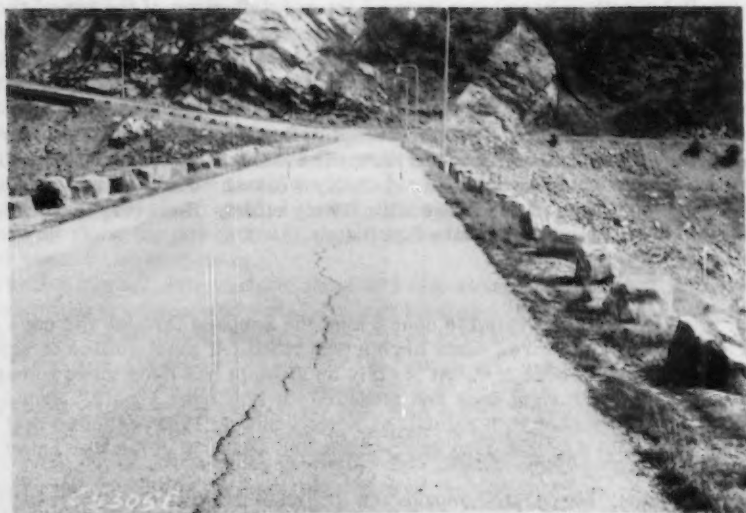
Fig. 5. Watauga Dam—Cracks forming along upstream shoulder of core

Progressive settlement along both shoulders for the full length of the roadway at Watauga has been noticeable for several years. Cracking on each side of the pavement (see Figs. 5 and 6) has been filled with asphalt several times. These cracks seem to follow roughly the edges of the earth core beneath the pavement. In 1957 there was a vertical displacement of up to four inches in a 50-foot section on the downstream side near the right end. This larger crack was enlarged and backfilled with clay and surfaced with hot mixed asphaltic concrete. A shorter area on the left end on the upstream side required similar treatment. The greatest settlement appears to have occurred at the extreme left end on the upstream side at the edge of the shoulder.

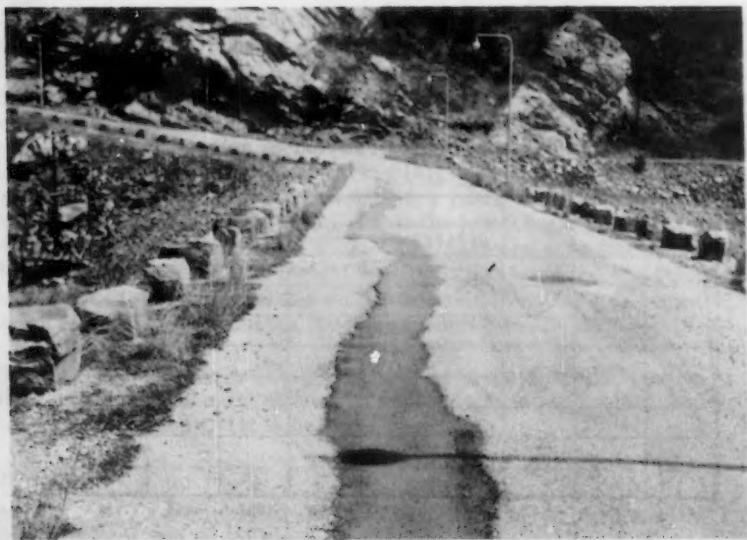
Fig. 6. Watauga Dam—Crack along downstream shoulder of core cut out, filled and sealed

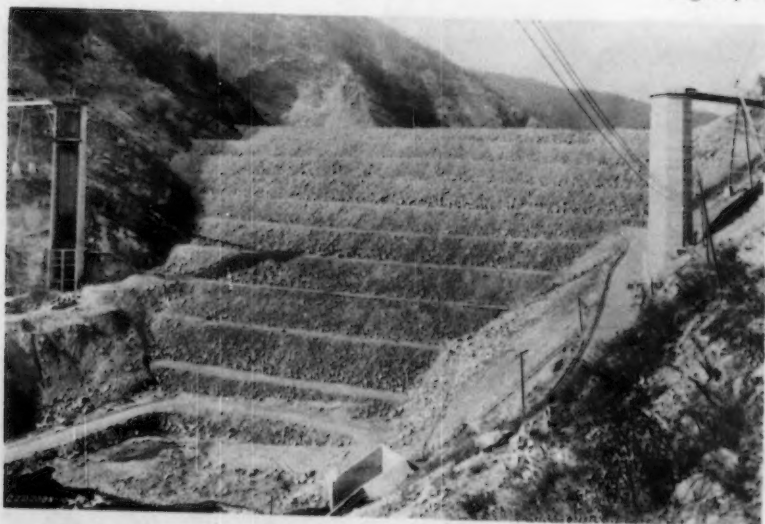
Fig. 8. Watauga Dam—Upstream View Near End of Construction

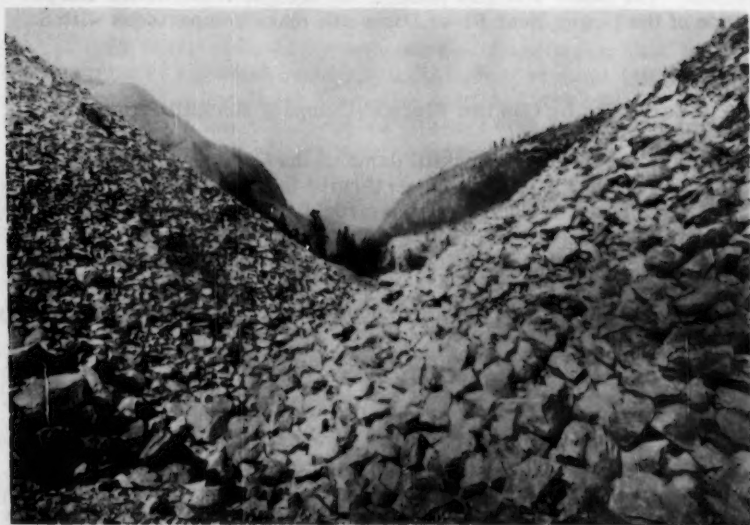
FIG. 2 THE MEETING OF 3910 LEFT ABUTMENT AND 3800 RIGHT ABUTMENT LIFTS - SALT SPRINGS DAM

The photograph, Fig. 2, shows the 3910 lift and the 3800 lift coming together. The rock of the left abutment 3910 lift is observed to be much smaller than that of the 3800 lift. This was uniformly the case since the spillway quarry was equipped to handle rocks up to only 2 cu. yd. size, whereas the right abutment quarries could handle 8 cu. yd. and larger rocks.

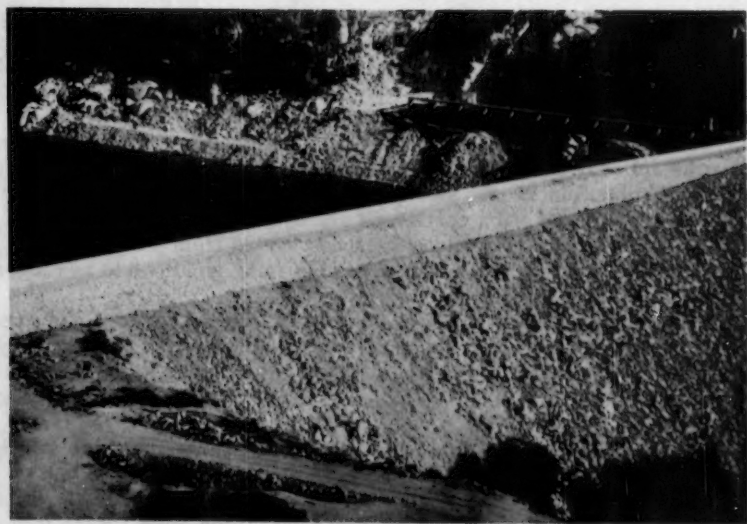
FIG. 3 COMPLETED DAM WITH SPILLWAY GATES AND COPING WALL ADDED IN 1947 - SALT SPRINGS DAM

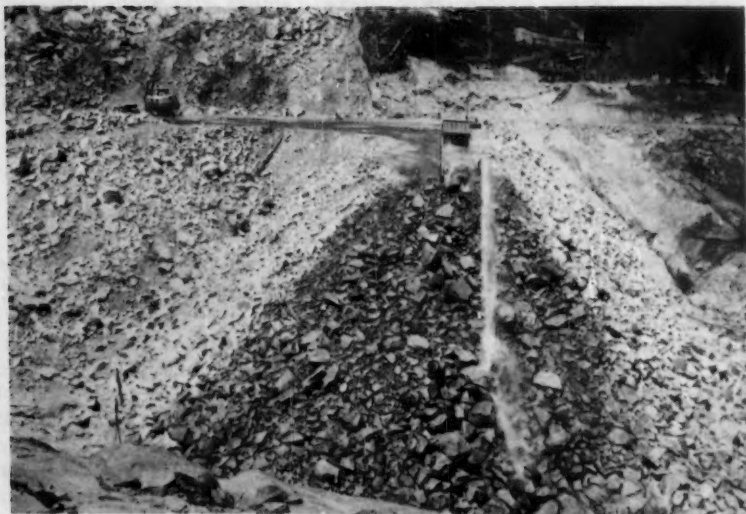
FIG. 12 DUMPING ROCK ON 120 FT. LIFT  
LOWER BEAR RIVER DAM NO 2

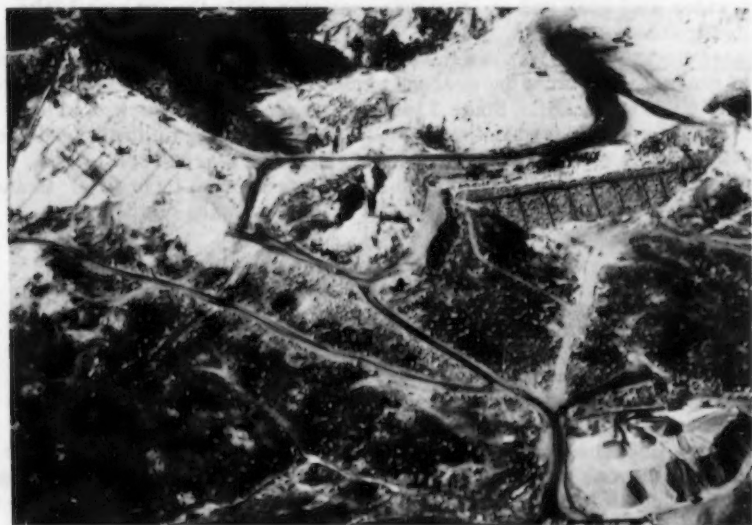
FIG. 18 AERIAL VIEW DURING CONSTRUCTION  
LOWER BEAR RIVER DAMS NO. 1 AND 2

A detailed and illustrated description of construction is presented in references (24), (25), (26) and (27). Photographs of construction are presented in Figs. 12, 13 and 18, and completed dam in Fig. 19. Table II gives a tabulation of physical data.

Dumped Fill.—Dam No. 2 was constructed essentially in one lift, which became the haul road to Dam No. 1, Figs. 11 and 18. Quarry waste was dumped on the downstream face outside the downstream design slope of the dam to

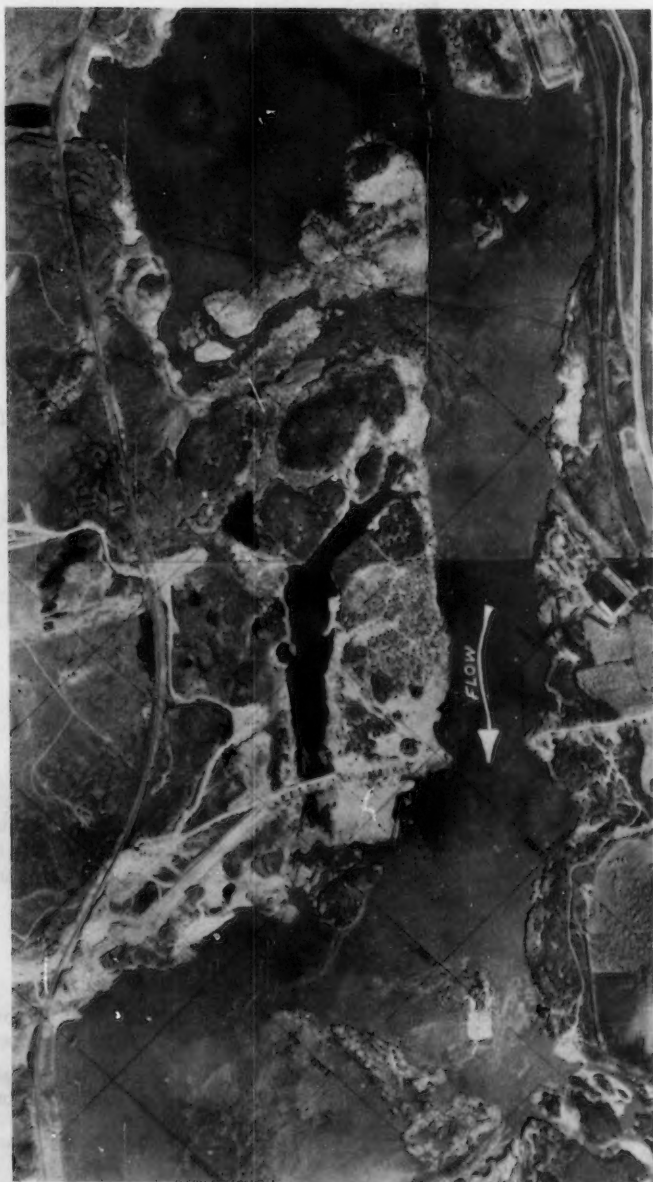
FIG. 1 - View of Dam Site April 1951

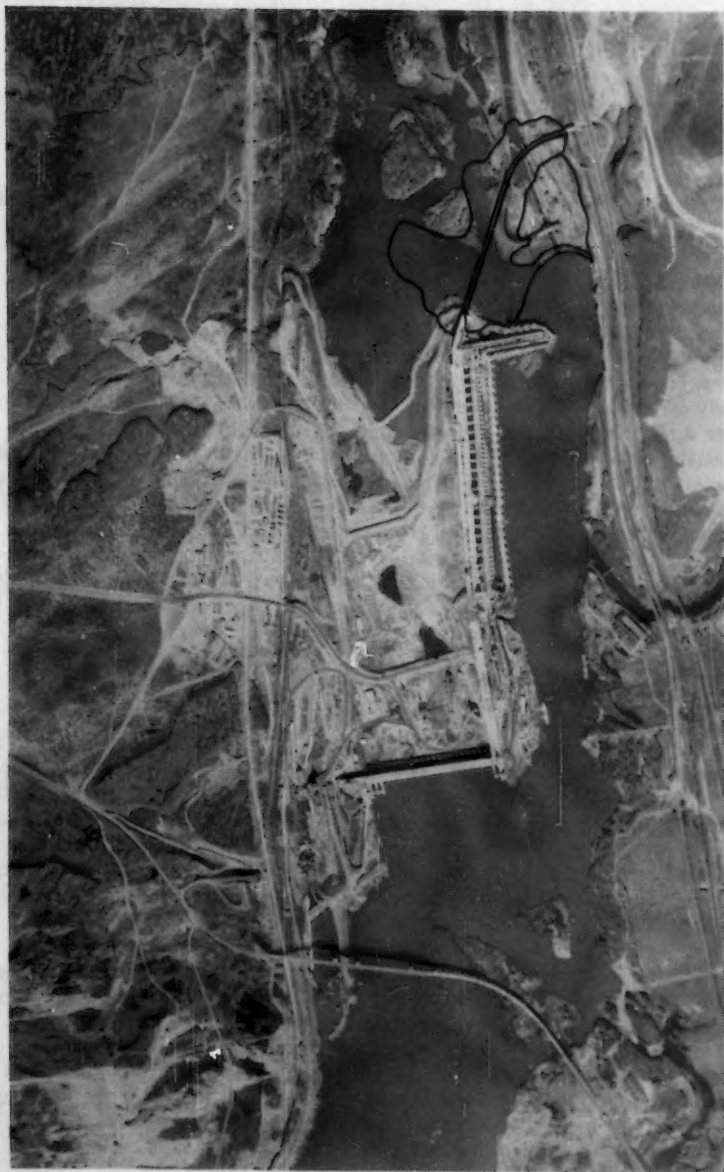
FIG. 2 - View of Construction March 1956

The general plan developed for constructing the closure dam consisted of first constructing a dumped rock diversion fill to divert the river flow through eight skeleton units in the powerhouse, then completing the closure dam by raising the dumped rock fill and placing an impervious blanket on the upstream face.

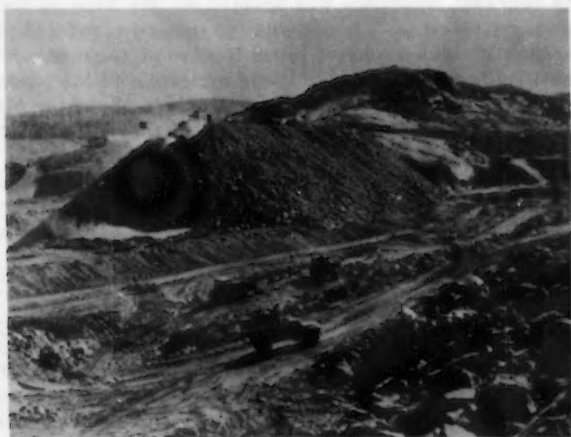
FIG. 13 BERSIMIS DAM - ROCKFILL

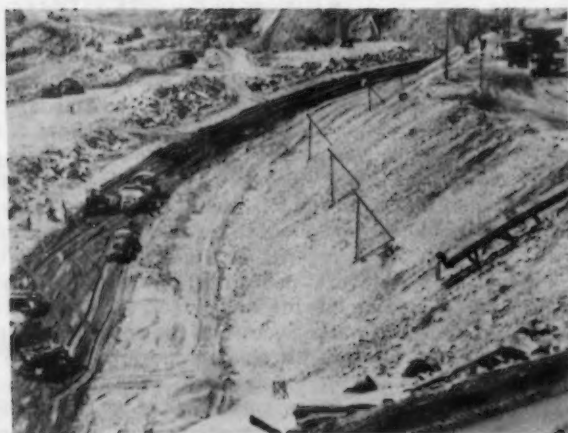
FIG. 14 PIPE FOR PLACING TRANSITION MATERIAL

Transition materials were used both upstream and downstream of the core and also under the rockfill on the north bank of the Bersimis dam. These materials were spread and compacted by bulldozer. To prevent bulking of the

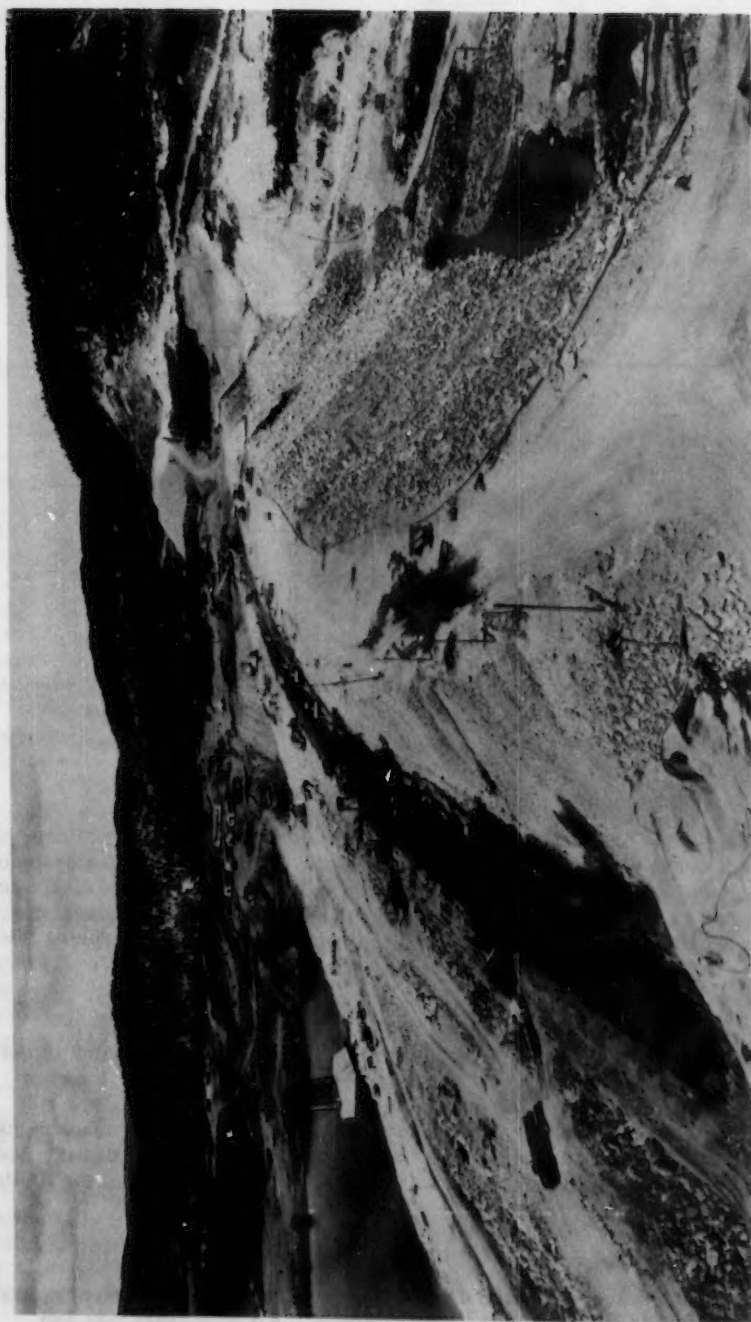
FIG. 15 BERSIMIS DAM - GENERAL VIEW SHOWING CONSTRUCTION

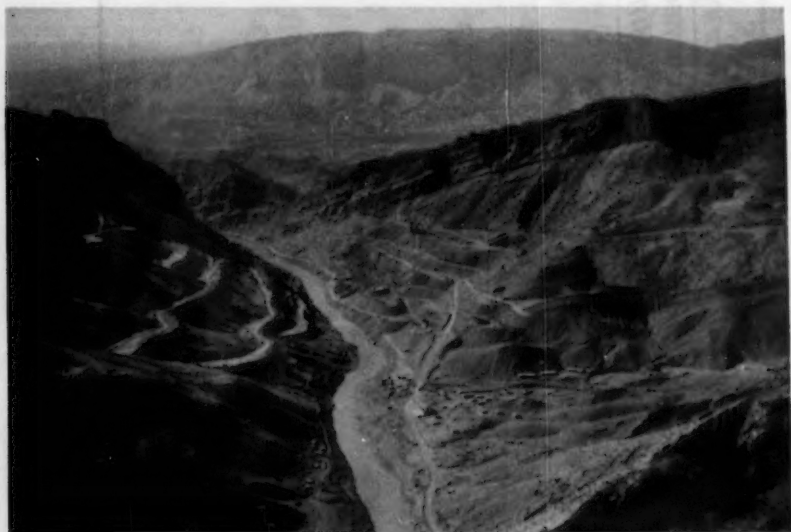
Fig. 5

VIEW LOOKING DOWNSTREAM  
DERBENDI KHAN PROJECT

The gorge topography of the Derbendi Khan site is emphasized by the nearly vertical cliffs of Qarah Chauq limestone, which form the top of the gorge walls on both abutments above the dam and spillway and can be noted in Figure 5. From the foot of the limestone cliffs talus slopes extend down to the river banks. The talus has in almost all areas weathered to a soil which supports sparse vegetation to the extent permitted by the semiarid climate.

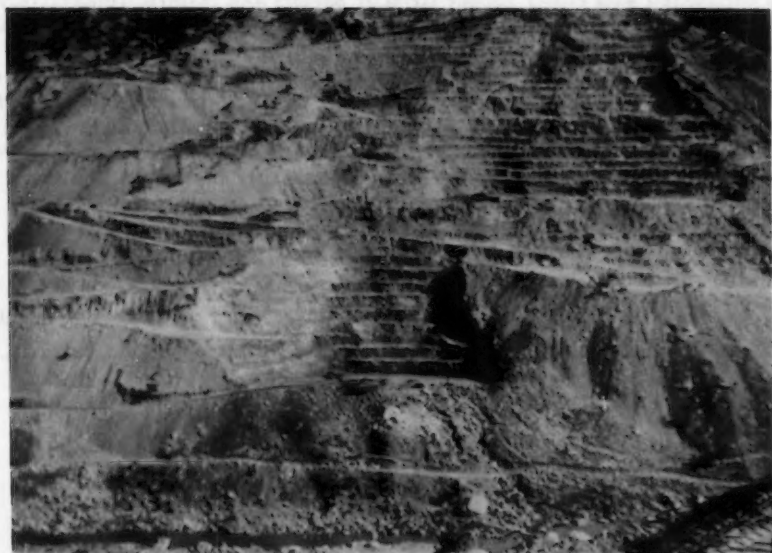
**Fig. 11**

**LEFT ABUTMENT EXCAVATION  
DERBENDI KHAN PROJECT**

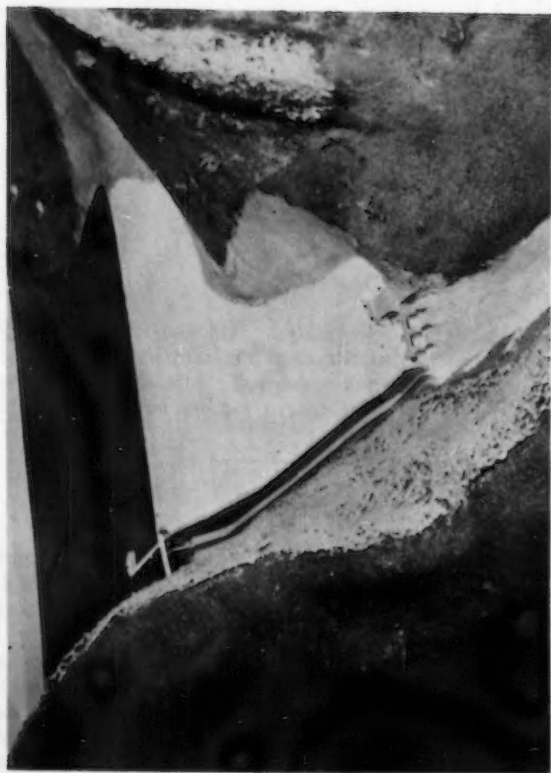
Fig. 14

MODEL OF COMPLETED  
DERBENDI KHAN PROJECT

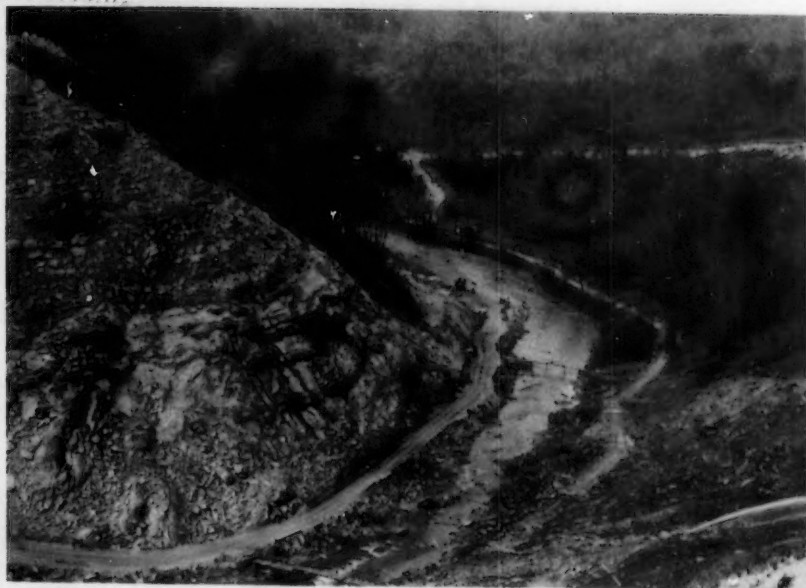
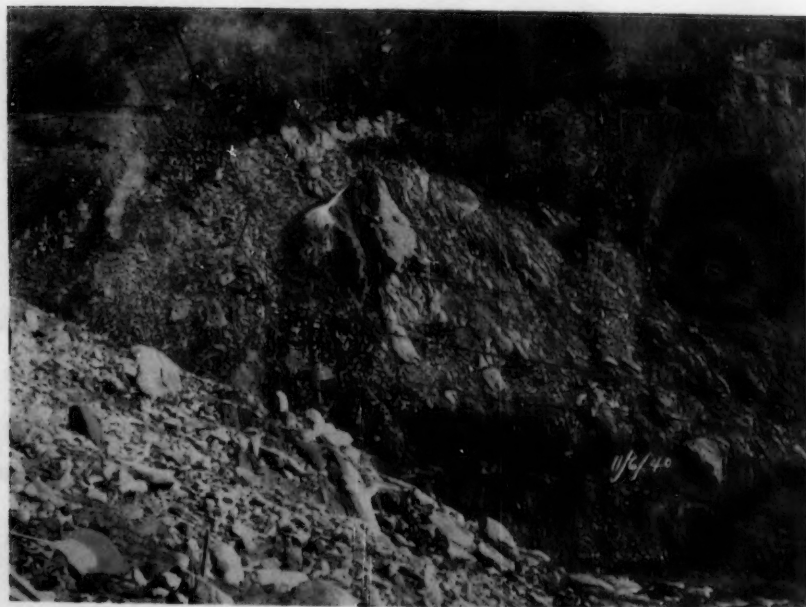
The dam site is at the upper end of the Nantahala gorge, where the river flows between a rocky promontory on the left bank and a 40-degree solid rock slope on the right bank. (Figures 1 and 2.) The rock at the dam site is a metamorphic sandstone, called arkose. While the bed rock has been folded it occurs at the dam site in massive strata with few cracks or seams. It is exceptionally water-tight. It is an excellent site for any type of dam, except an

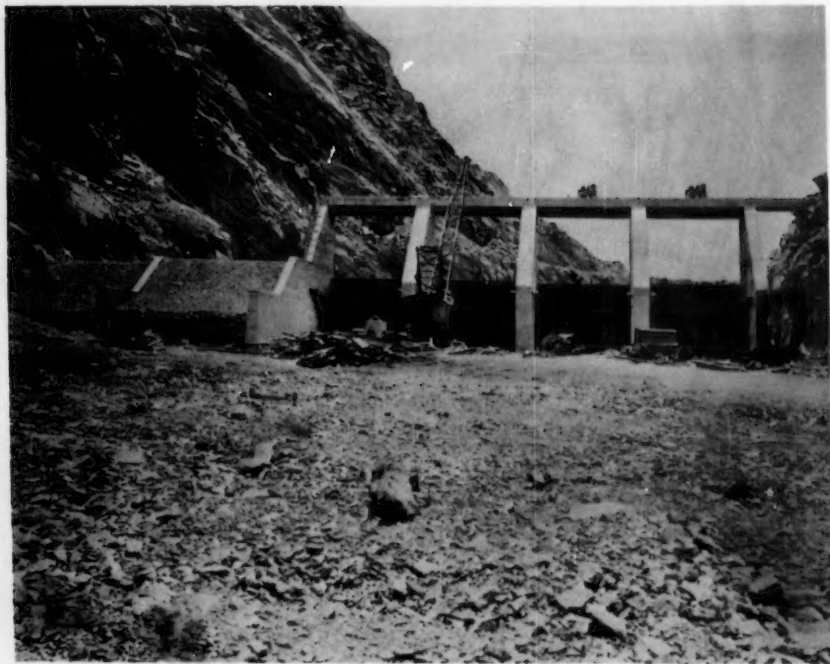
Figure 5

encroaching on the 7 feet of freeboard above the surcharge level. (Figure 5.) The excavation from the spillway provided the rockfill for the dam. The spillway channel ends on a steep hillside, 400 feet downstream from the toe of the dam. The spillway discharge cascades into the original river channel.

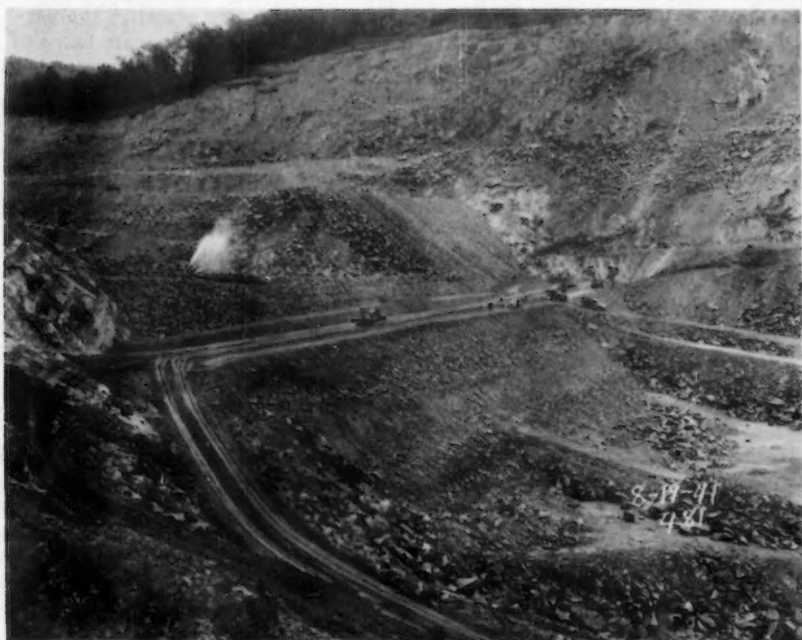
Figure 6

The dam was designed as a triangular section rock-fill across the gorge, to be placed in one or more lifts as convenient for construction. (Figure 6.) Selective dumping placed the largest rock in the downstream part of the fill and the smallest quarry-run rock in the upstream part of the fill so that the voids in the main rock-fill would become progressively larger from the upstream face to the downstream face. Both the upstream and downstream slopes of the rock-fill were to be the natural angle of repose of the dumped rock. The first filter layer, 14.75 feet thick, was composed of selected rock not larger than 10 inches and not smaller than 3 inches. The second filter layer, 6.5 feet thick, was composed of crushed rock not larger than 3 inches and not smaller than 1/2 inch. The third filter layer, 6.5 feet thick, was composed of crushed rock fines smaller than 1/2 inch. The sizes specified and the grading of the filter materials produced by crushing fulfills the requirements that voids between the larger particles are filled by progressively smaller particles so as to prevent migration of the finer material. Theoretically, only a very thin filter layer would have been required. Actually, each

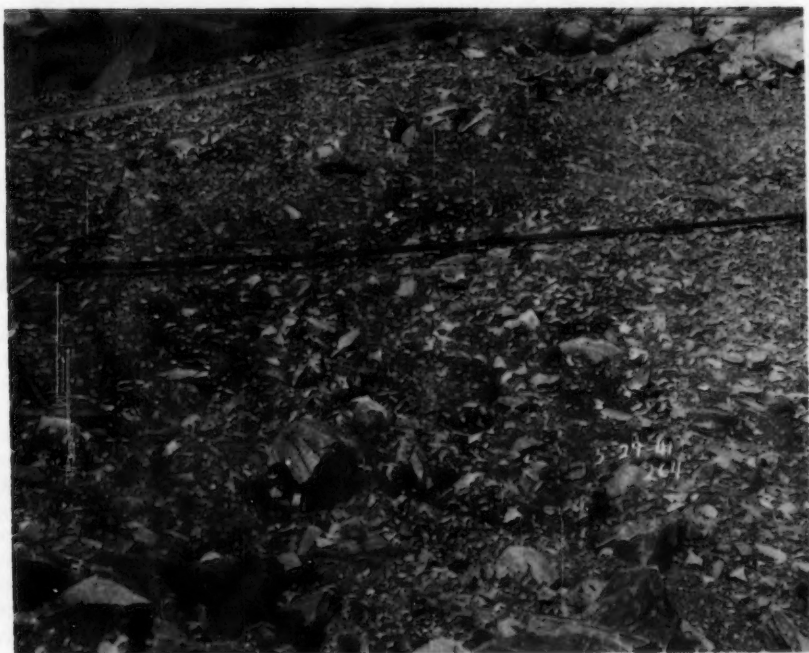
Figure 8

The character of the rock and the methods of shooting produced quarry-run rock varying in size from 10 tons to dust. Normal quarry operation resulted in some trucks being loaded only with large rock, some loaded with small rock, and some loaded with a mixture of intermediate sizes. Selective dumping permitted placing most of the large rock in the downstream section of the fill and most of the small rock in the upstream section of the fill. This was accomplished without interfering with the quarry operation. Mention should be made of the compacting effect on the fill when dumping at the top of a high lift, particularly where the rock was large. It had been intended to smooth up the downstream slope but it was found impossible to move any of the rock without shooting. It was also found to be difficult and expensive to smooth up the slope by adding rock after completion of the fill. For these reasons the downstream slope of the fill was left exactly as placed. Some hand chinking was done on the upstream slope, particularly near the bottom where the voids were large. The surface of each lift was thoroughly scarified and sluiced to remove fines. (Figure 8.)

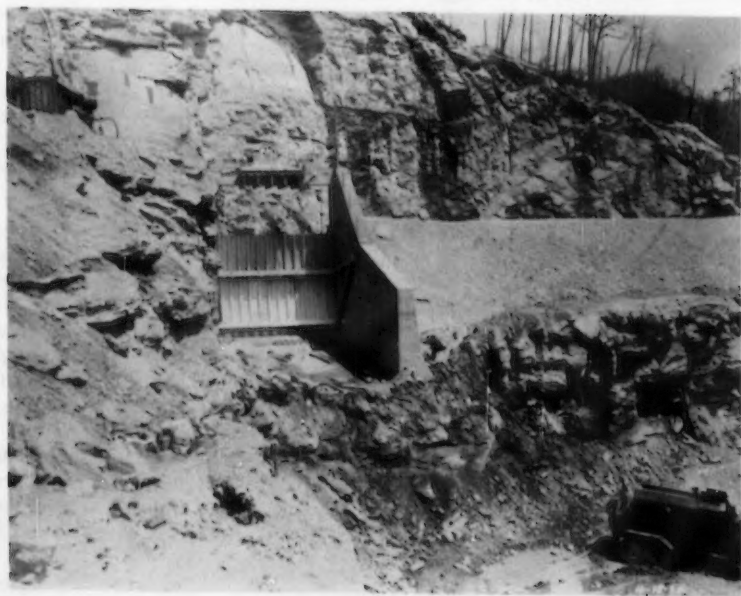
| Figure 18 | Tennessee Creek Dam - Partially Filled Reservoir |

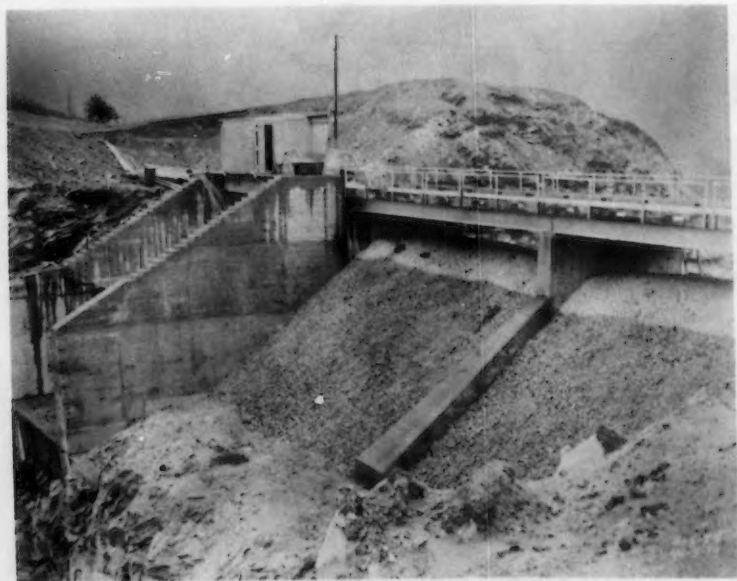
| Figure 20 | Wolf Creek Dam - Partially Filled Reservoir |

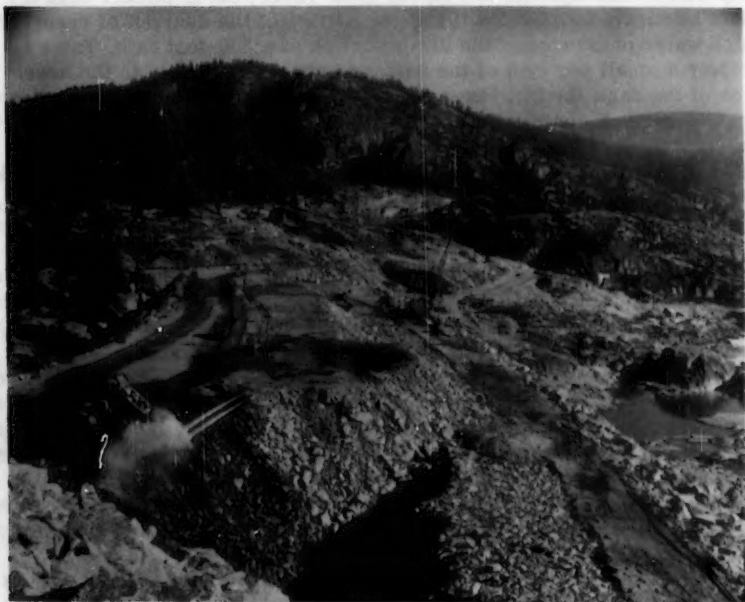
Fig. 7. Kings River Project Wishon Dam. Dumping rock near the center of the dam. The construction involves hauling 3,687,000 cubic yards of dumped and placed rock in 17 cubic yard trucks. The double monitor is operated by one man.

Fig. 7 shows the massive granite formation at the site and an interesting stage of construction. The photo is taken from the end of the wing section dumped fill, some of which is in the left foreground. Dumping is proceeding at the 6450 lift, which was carried to the full width of dam rather than partial width as shown on Fig. 5. Placed rock work is proceeding from the face lifts, which were used essentially as proposed on Fig. 5. In the right foreground a portion of the face lift has been scarified to receive the next lift of dumped rock. The pile of fines was formed by monitor and bulldozer in the scarifying operation, and was later removed. From the main lifts the scarified fines are cast over the downstream face. Scarifying is by a bulldozer carrying a monitor that operates at 200 psi. This high pressure is possible by operating at off-shift times when other monitors are shut down. Large rocks may be seen high up on the dumped slopes, which is desirable. It takes well interlocked surface rocks to stop the large rock from sliding further down the slope.

**Dumped Rockfill.**—The spillway quarry and a main quarry near the right abutment, Fig. 7, furnished the rock for the dam. References (3), (6), (7) and (9) give a thorough description of quarrying, hauling and sluicing the rockfill. The powder factor was high, 1.0 lb. per cu. yd., due to deep fissures in the rock. Payment was made at a specified 50 cents a solid cubic yard for all material removed from the quarry site, including overburden. A bid price was paid for the yardage in the pay lines of the dam. The bid price included haul roads, hauling, sluicing, scarifying of lift surfaces and the additional cost of quarrying over the fixed payment. The fixed price is intentionally less than quarry cost. It gives both owner and contractor an interest in having minimum waste and reduces risk to the contractor if overburden or waste is excessive. Upon completion of the dam, it was computed that the dumped rockfill contains 32% voids. The rockfill at Courtright at the end of 1957 also was computed to contain 32% voids.

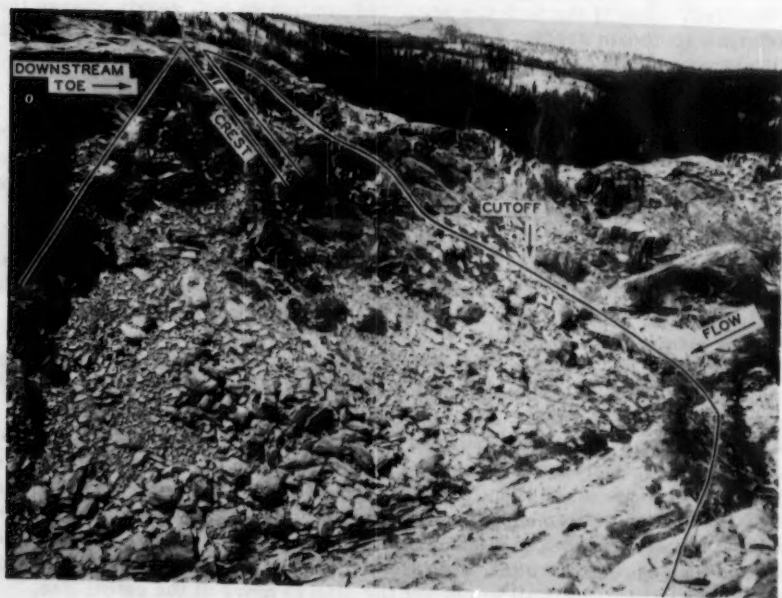
Fig. 18. Talus remains in place as rockfill.

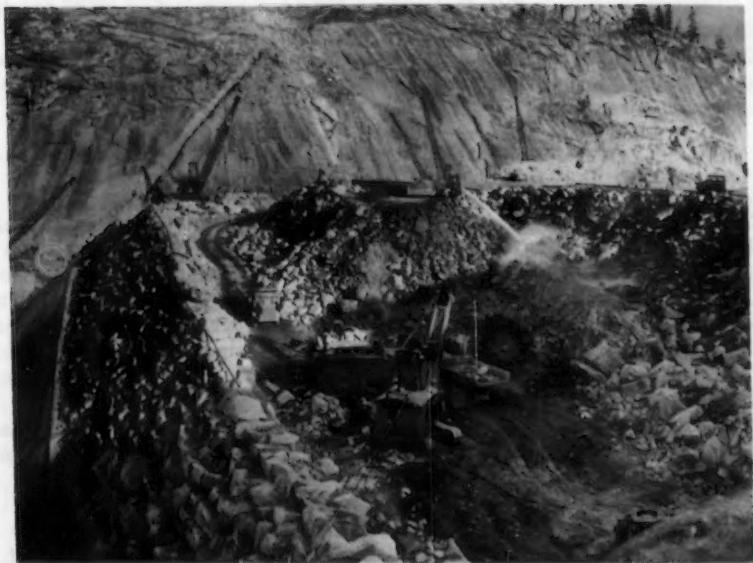
Fig. 21. Kings River Project. A new lift has been started in the background in the construction of Courtright Dam. The cutoff trench carved into the left abutment beyond the crane near the edge of the dam in the background indicates the height still to be reached.

dumped rockfill was rising in a spiral and ramping was downward to the face lifts. Fig. 19A, October 1, shows access to a face lift from the left abutment while the right abutment access is being established. Figs. 19B and 21, November 1, show the stage of construction on the same day by isometric and by photograph. Access to the face lifts is possible from the right abutment access road. All the ramping is within the final cross-section of the dam. The 317-foot rockfill dam is constructed from four haul roads; one near streambed level, one on each abutment at intermediate levels, and one at the crest. Two quarries were used, one on each abutment.

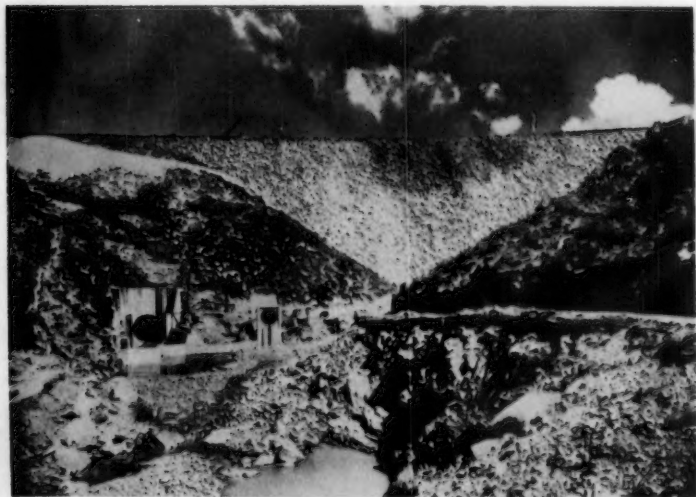
FIG. 16 — GENERAL VIEW LOOKING UPSTREAM.  
(STAGE 3 LIFT FINISHED)

NOTICE ON THE RIGHT BANK THE DEPOSIT OF FINES  
REMOVED FROM STAGE 1 LIFT, THE PORTAL OF THE  
SPILLWAY TUNNEL AND THE OUTLET BUTTERFLY VALVE.

One problem that required attention was the accumulation of fines in the area of contact between the placed and the loose rock caused by the fines accumulated on the construction lifts (Fig. 16) being carried down when the lorries dumped their supply of rock for the construction of the placed rock layer. With the use of monitors, and even by hand excavation, those fines were removed in order to uncover the large rocks of the loose rock-fill against which the placed rock rested. The supply of rock to each place of work was not without some difficulties chiefly in the areas furthest from the lifts because the rocks reached great velocity and were in the risk of falling along the upstream face of the placed rock or on the part of the impervious face already concreted. With the previous placing of large blocks forming a retaining wall, or by constructing strong timber defences, this problem was overcome and very few large stones went beyond this fixed limit.
